Crowsnest Pass Facility Evaluation Report

**Pass Community Swimming Pool
11973 20 Avenue
Blairmore, Alberta**

**Architecture | Arndt Tkalcic Bengert
October , 2014**

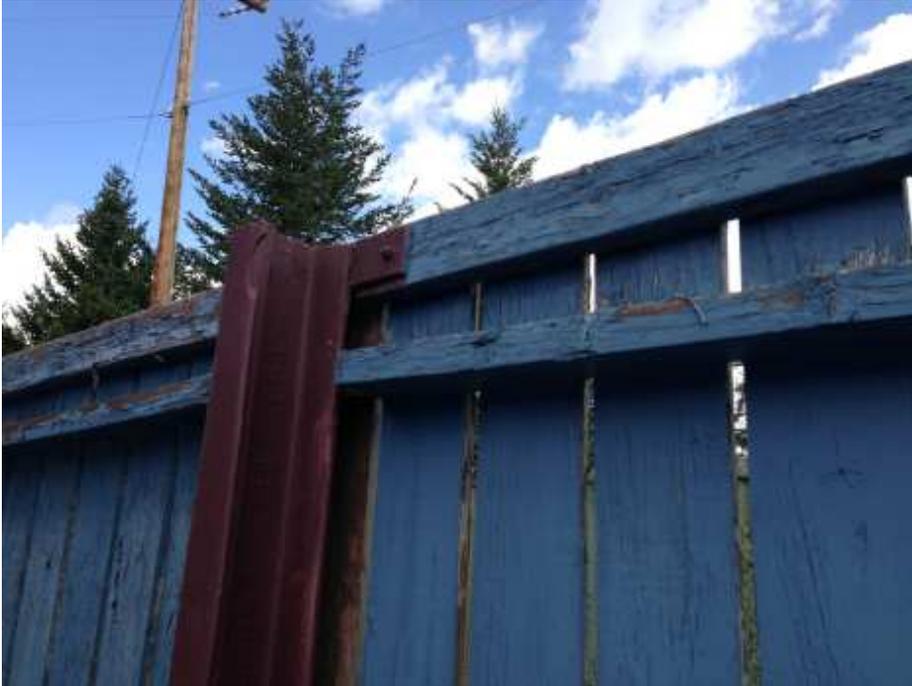
C1 - Wood Fencing

- .1 The building site has positive drainage to 20 Avenue on the south and 121st Street to the east. The pool is located adjacent to a secured lane to the north east. The north west side of the pool yard is a park. A concrete sidewalk has been added to the east basement mechanical room access. The chain link fencing to the southwest and north west of the pool deck appear in acceptable condition with some repairs required. The north east side of the pool deck is closed off with a wood fence system supported on steel posts. (Refer to Photo C1) The wood fence has deteriorated and should be replaced, the steel posts could be refinished and repainted.

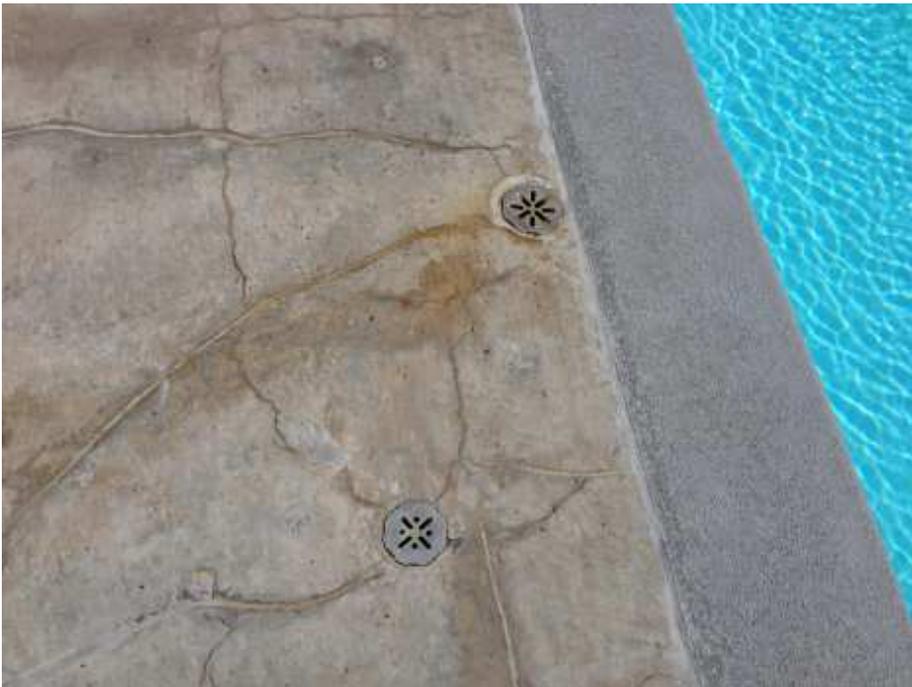
C2 - Pool Deck Cracking

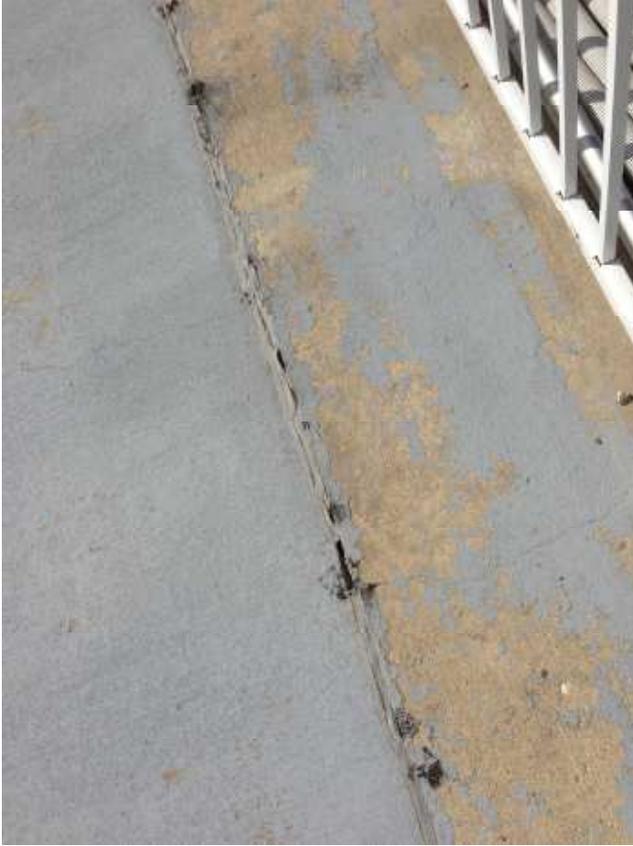
- .2 The pool side concrete deck has extensive cracking and a major fault line crack from the wading pool through to Diving tank. This crack should be reviewed by a pool engineer for direction in proper method of repair. Additional drains appear to have been added into the concrete deck and cracking is ongoing. Repairs and replacement of the concrete deck is required to be completed to eliminate further damage. . (Refer to Photo C2). The newer wading pool had concrete cracks repaired and deck painted in 2011. Since the repairs a black substance has been found to be coming from the joints and the paint has not lasted 2 seasons. It appears that an inappropriate material was used in the joints and should be removed and replaced with an appropriate epoxy joint filler grout.(Refer to Photos C3, and C4).

C3 New pool deck peeling paint and crackfiller.

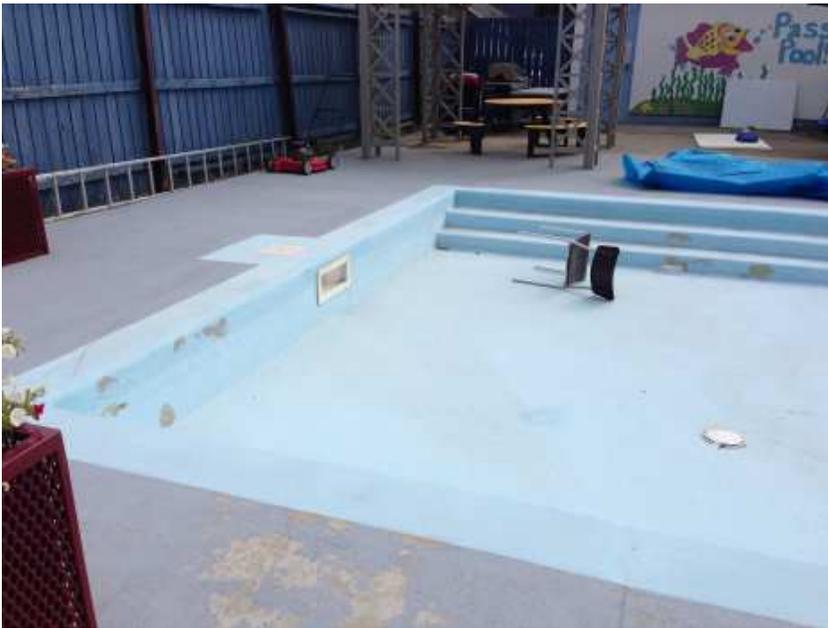
C4 - Waiting pool unable to be used

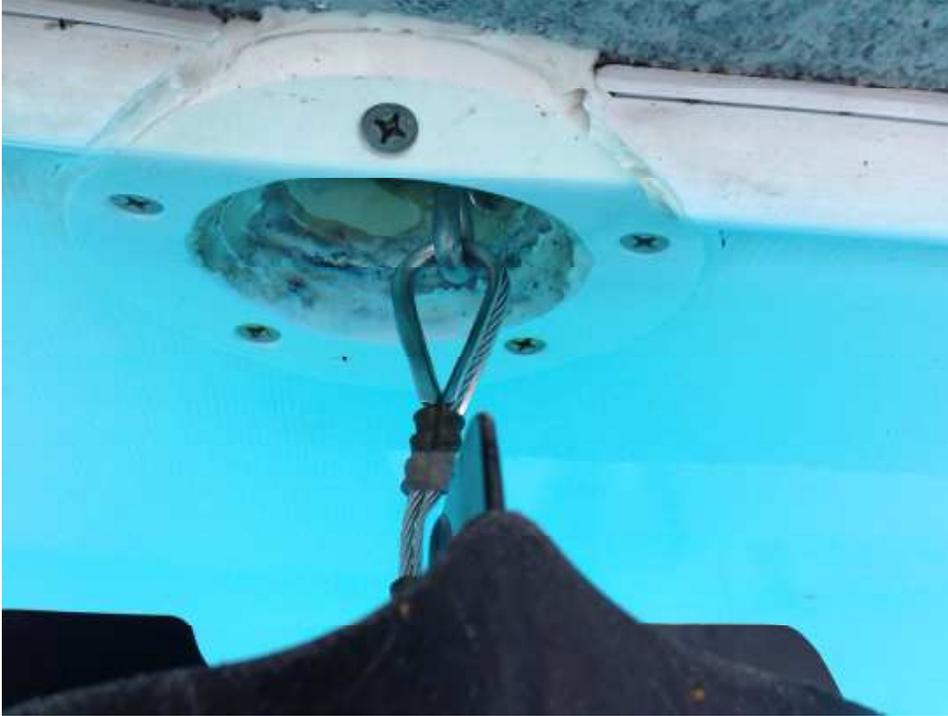
- .3 Staff noted areas of concern with respect to the pool liners. The liner is pulling away from the structure and the sagging of the liner is more evident when the pool is drained. The pool liners also appears to be damaged at the lane rope inserts and where the exit steps are located. The concrete is disintegrating behind the lane rope attachment and the concrete is being pulled into the liner and damaging the liner. There is a discoloring of the liner when the pool is drained - the liner turns green, blue and black. Recently when the town water system over flowed the liner turn yellow from ground

C5 - Lane rope attachments are pulling out and liner is damaged

water. The wading pool has a separate chlorine system and has not been running since a health inspection determined the alkalinity was too high. The wading pool system requires to be assessed by a pool engineer to determine how this system can be modified to meet the requirements for the alkalinity. (Refer to Photos C5, C6, C7 and C8).

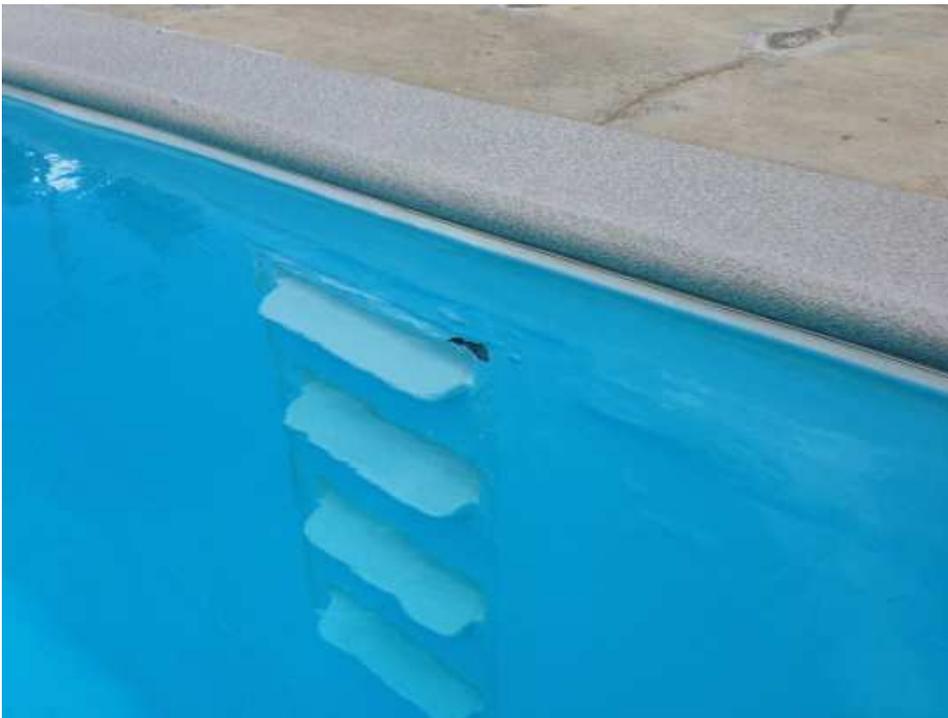
C6 - Liner is damaged and pulling away from concrete

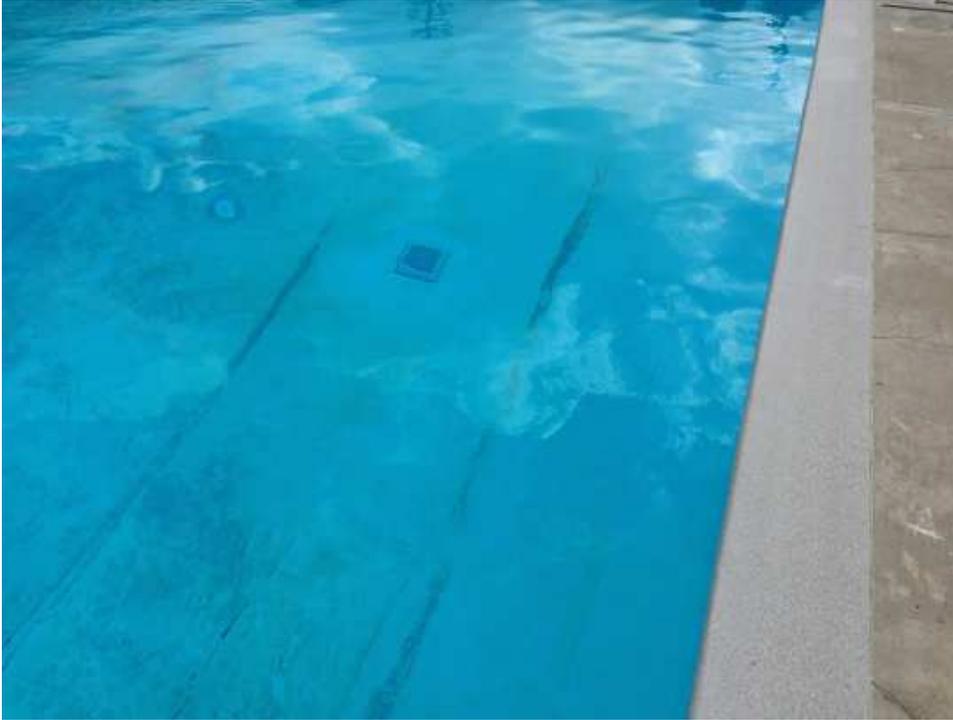
C7 - Pool liner discolouring

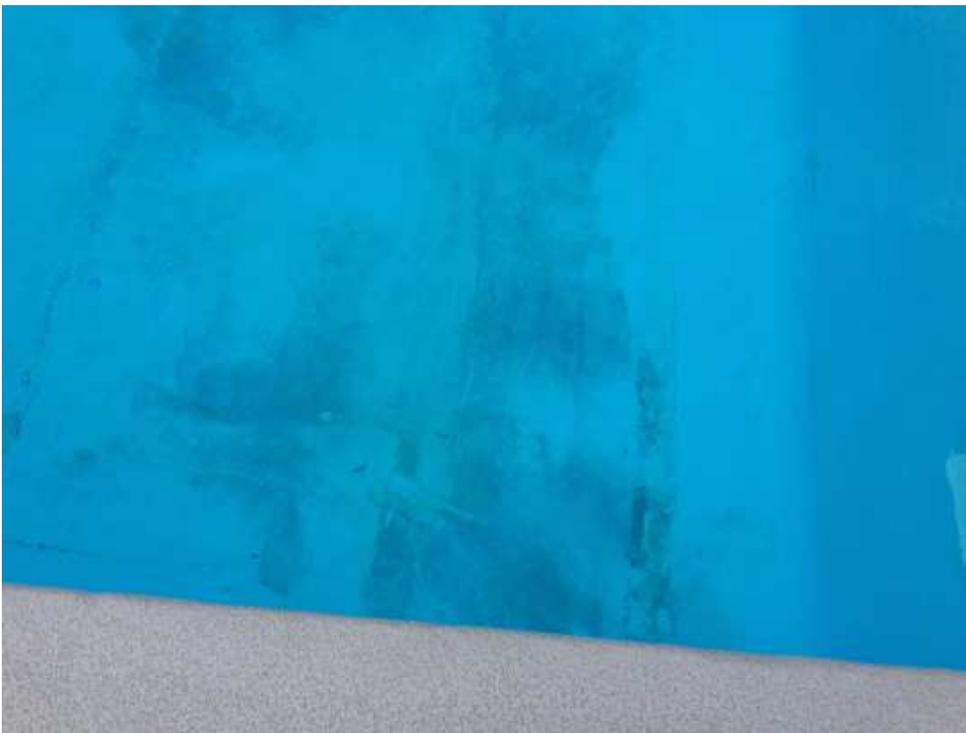
C8 - Pool liner discoloring

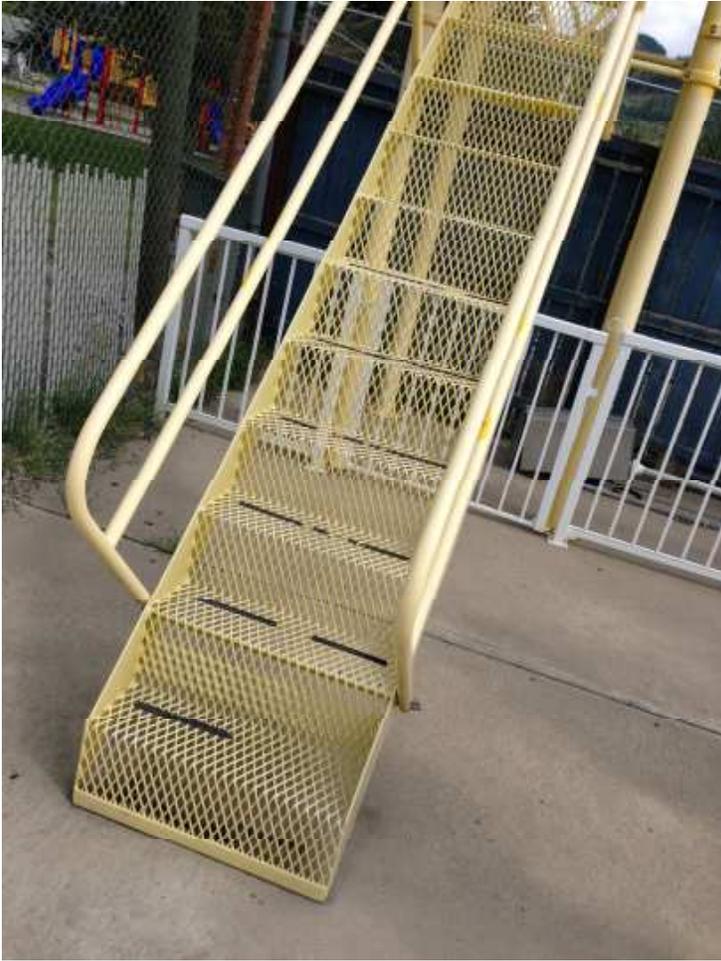
- .4 Pool equipment such as diving boards and ladders to slides appear to be deteriorating. Column supports are rusting and non slip tap on steps is worn away. Repairs and/or replacements are required. (Refer to Photo C9 and C10).

C9 - Non slip stair tread nosings require replacement

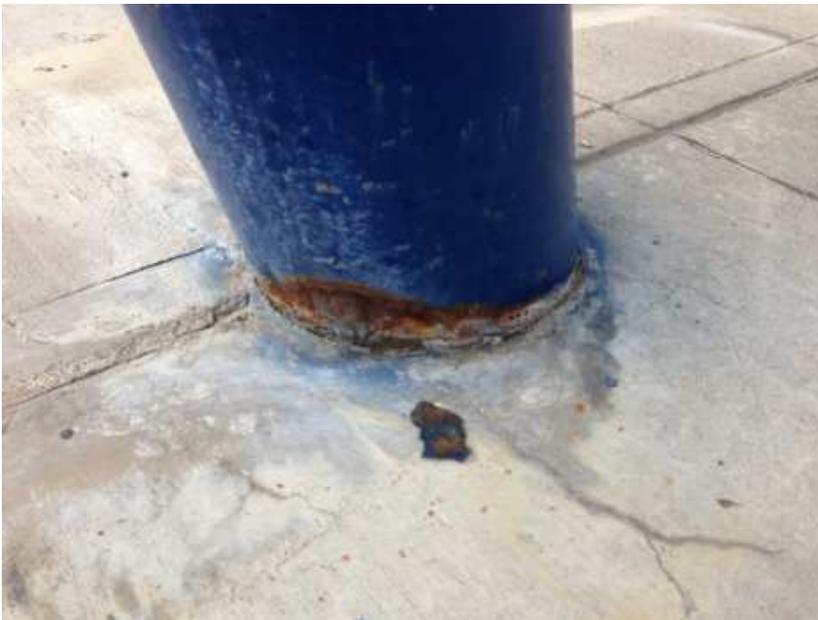
C10 - Pool equipment is rusting

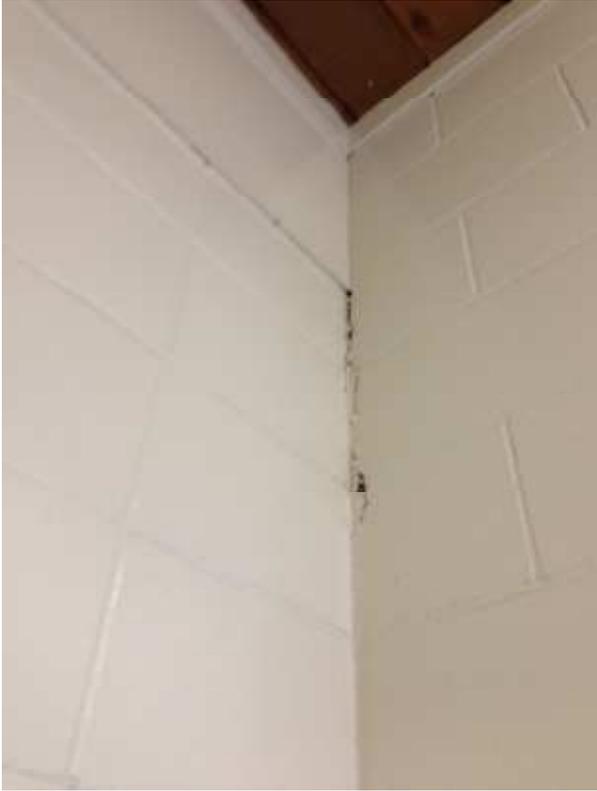
A1 - Cracks in concrete block Joints

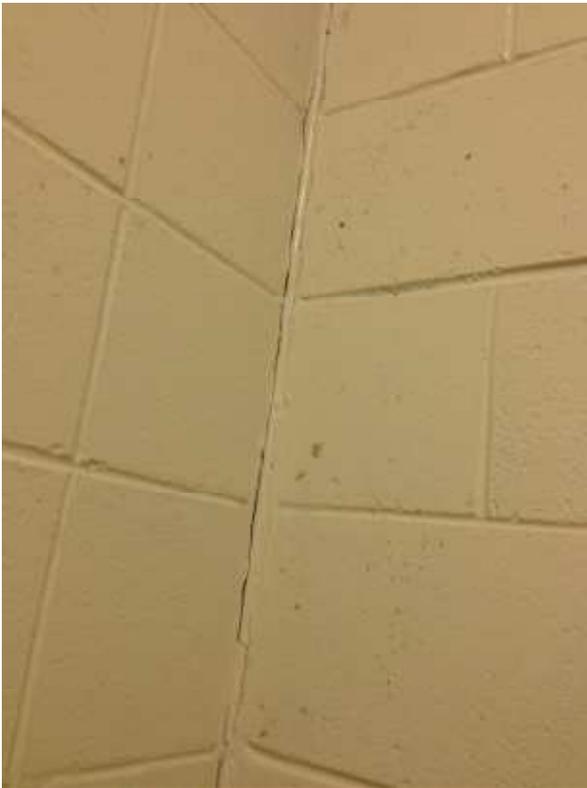
A2 - Cracks in concrete block wall joints

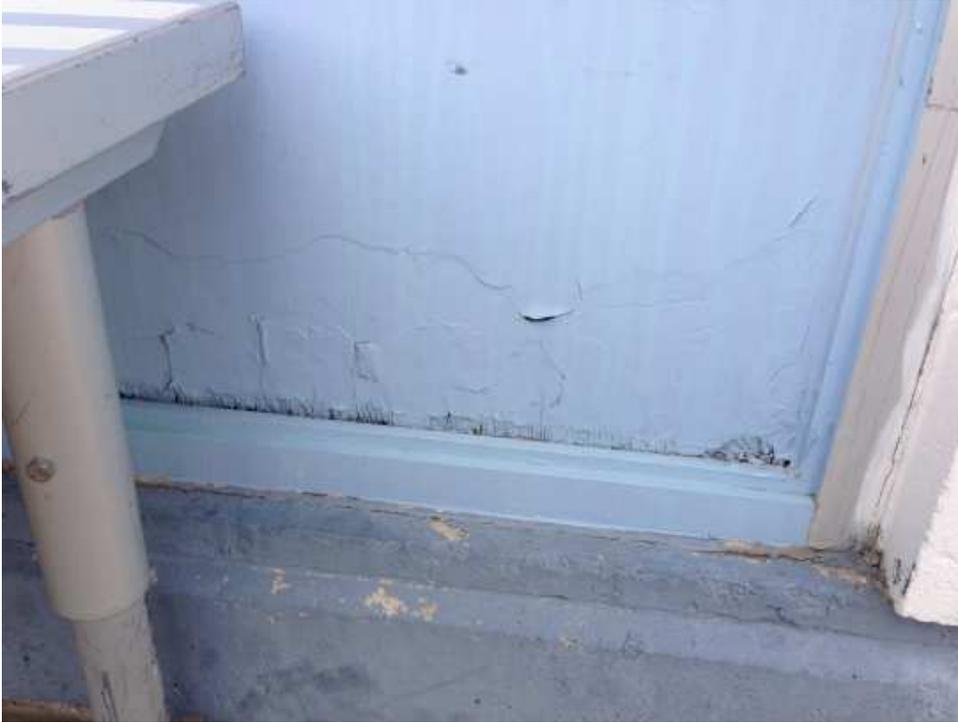
The exterior walls of the building envelope for this facility are primarily single wythe ribbed load bearing concrete block with painted plywood fascia panel between the projecting glu-lam beams. The pool side block wall is a smooth face block painted finish to both the interior and exterior. It is noted that the interior face of the exterior block walls is painted with no true vapour barrier. Cracks in the concrete block walls are evident and should be sealed before freeze thaw cycle cause further deterioration. (Refer to Photos A1, and A2). The main entrance doors are aluminum storefront with painted plywood infill panels below the mid door horizontal mullions. Doors and windows from the office to pool side are also aluminum storefront. Plywood infill panels are worn and damaged and should be replaced with proper metal spandrel panels. Caulking around the aluminum storefronts are damaged and flashing are missing. Incorrect caulking and grout at the storefront frames appears to be causing water to be unable to drain from the window frames causing deterioration of the materials. Storefront frames, glazing and doors should be replaced with new properly sealed units. Access from the men's and women's change areas to the pool side is through pressed steel doors and frames. Doors are noted as been damaged and steel is rusting and weatherstripping is missing. The poolside access doors are not barrier free. These doors should be replaced. (Refer to Photos A3, A4, and A5).

A3 - Plywood panel infill in storefront frames requires replacement

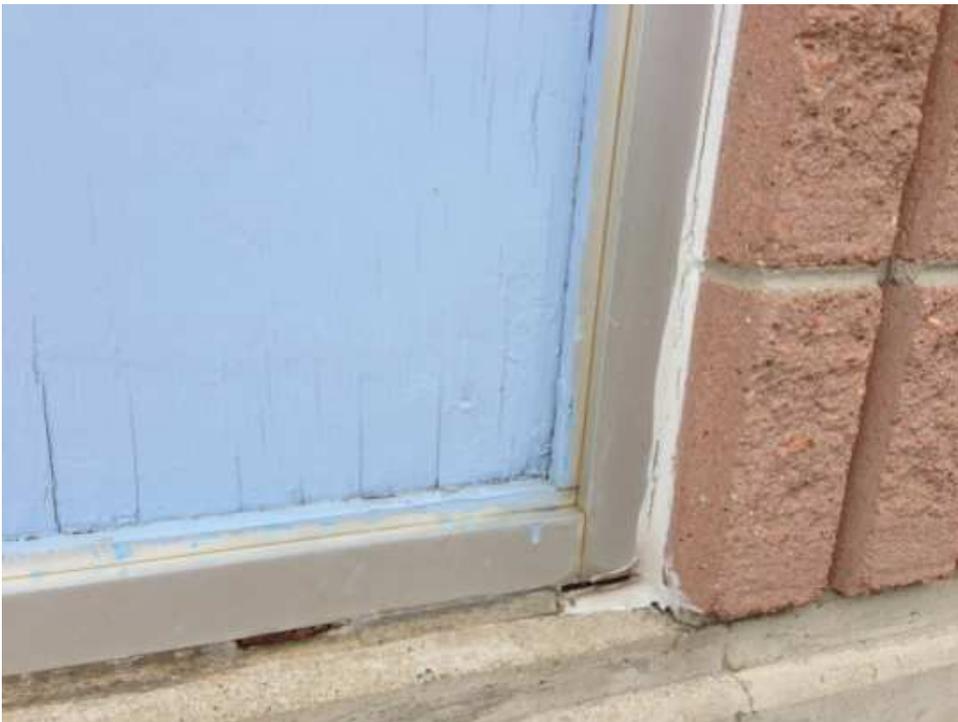
A4 - Caulking and grout filled joints require removal and correction

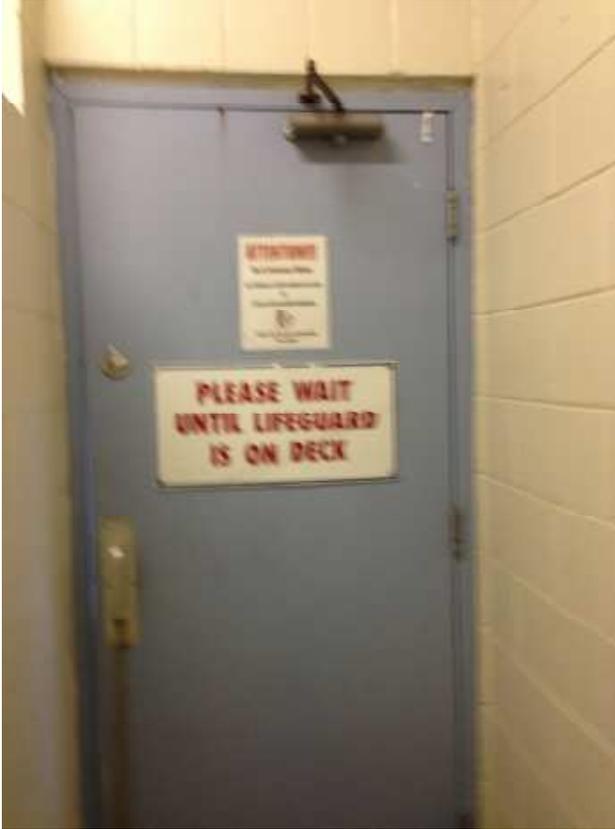
A5 - Hollow metal door deterioration and not barrier free

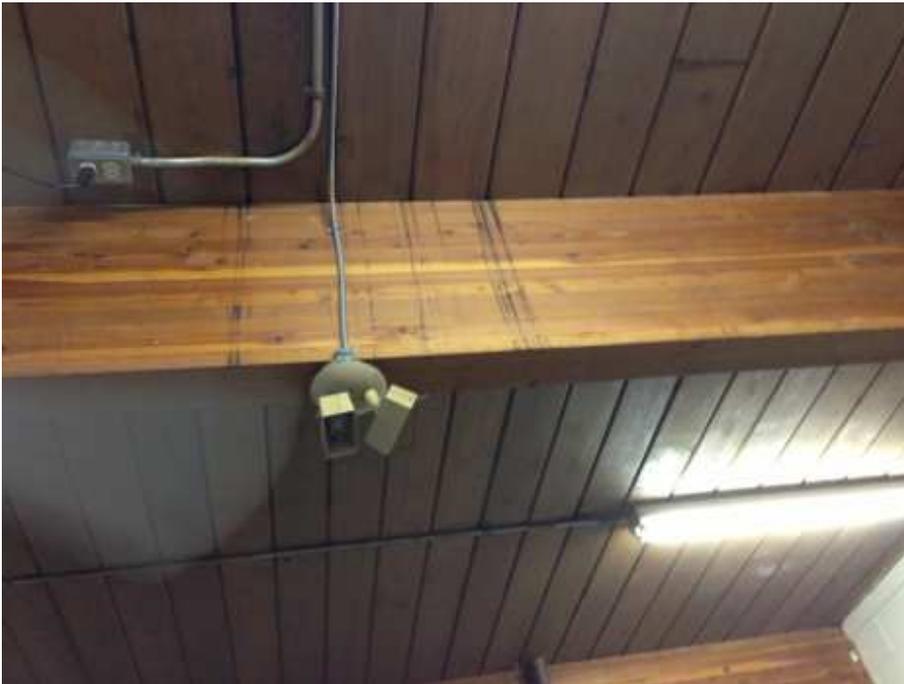
The roof is exposed heavy timber wood decking spanning across the glu-lam beams approximately 2.6m O.C. The roof membrane of the Pass Pool building is expected to be a vapour retarder with insulation, fiberboard, built-up bituminous roof membrane with asphalt and gravel ballast. Although no leaks have been reported there is staining noted on the glulam beams in the change areas. The date of the last roof replacement is not know. It is recommended that the roof be reviewed by a roofing inspector to determine the

A6 - Staining on Glu-lam beams from asphalt roofing

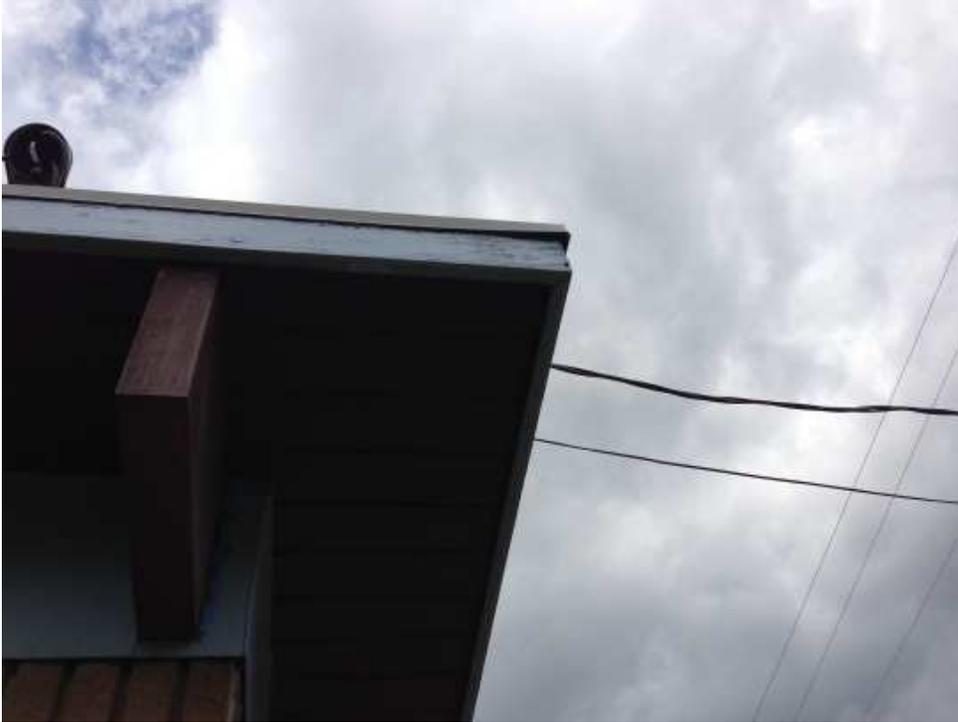
remaining life expectancy. The fascia band of the roof is painted wood and appears to be distressed wood. The fascia band should be replaced with a prefinished metal. Rainwater leaders are located on the exterior of the building. (Refer to Photos A6 and A7),

A7 - Painted wood roof fascia requires replacement with metal flashing

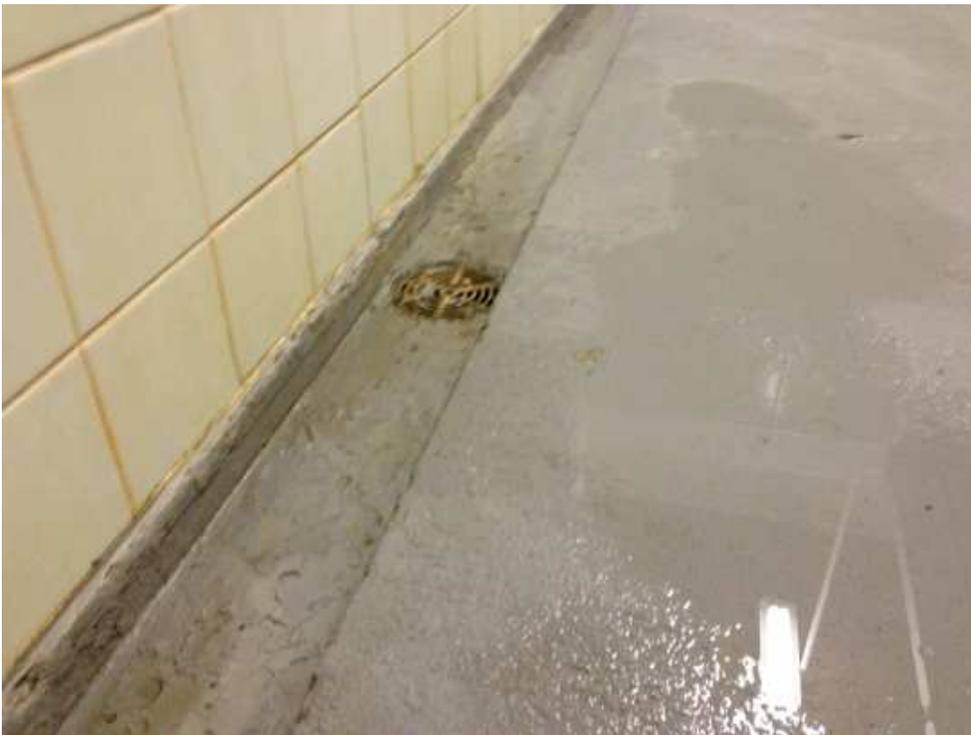
A8- Floor finish has deteriorated and requires replacement

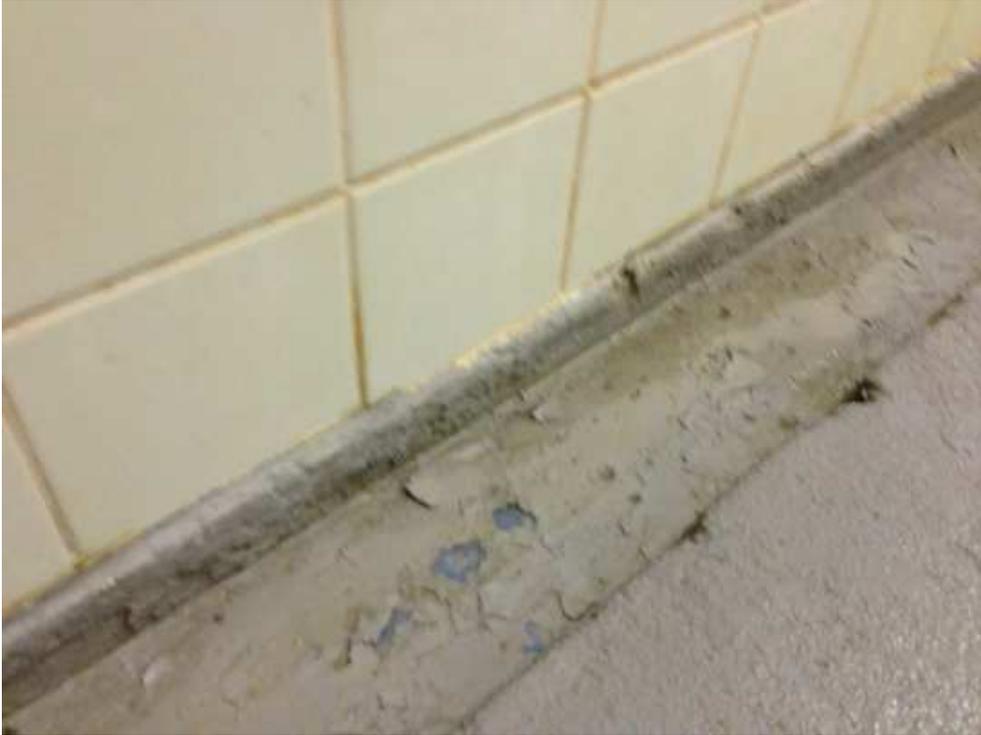
A9 - Floor finish requires replacement

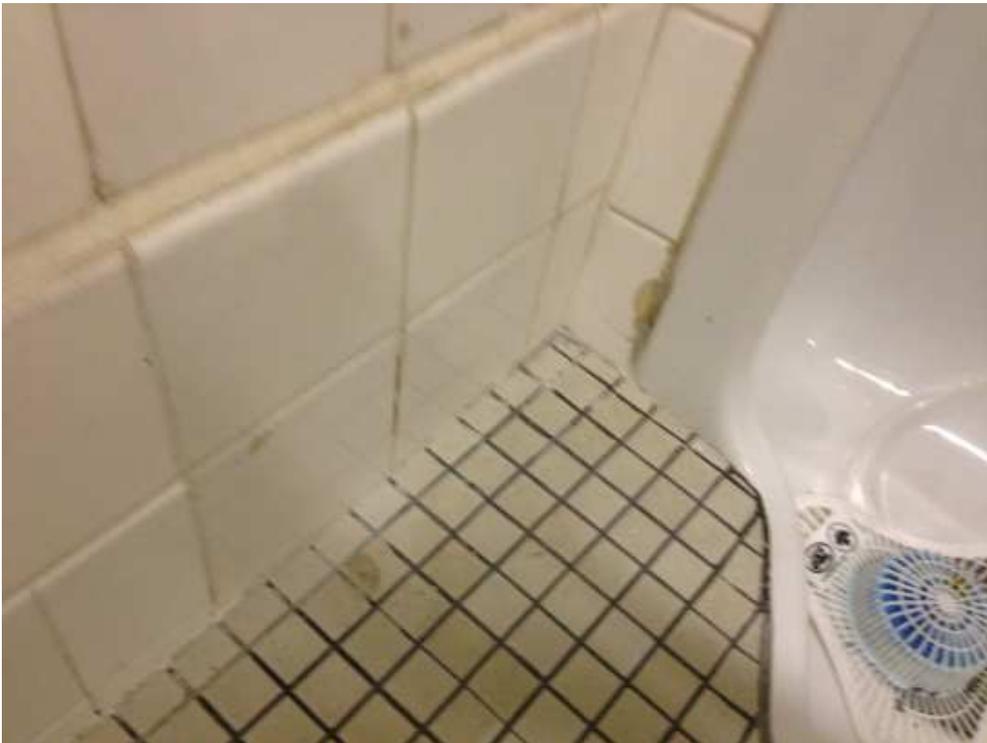
A10 - Ceramic tile requires replacement

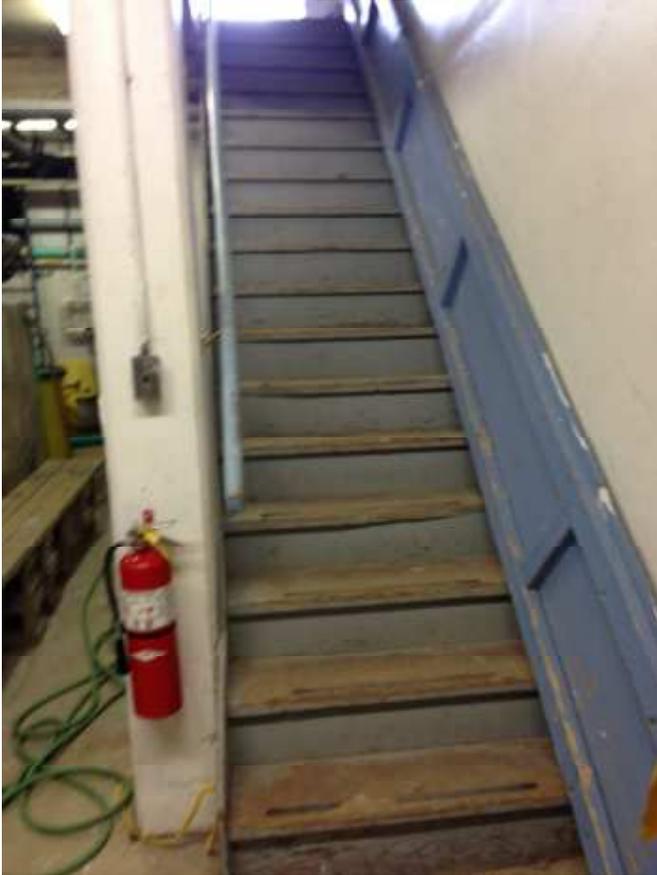
The basement mechanical room has a wood stair in critical condition and requires immediate replacement. (Refer to Photo A11).

A11 - Basement stairs required repair to treads risers and non slip nosing

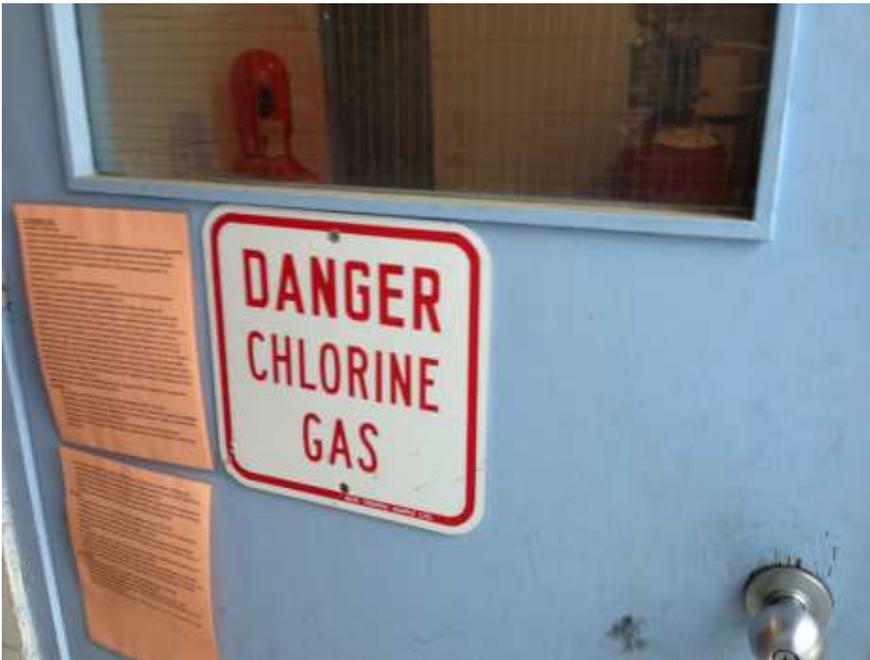
Access to the basement Mechanical Room is accessed through an open corridor and stair. Along this corridor is the Chlorine Room which is required to be protected with a fire separation and proper venting. The existing wood door with large glazed panel does not provide the proper fire safety. This wood door and frame requires to be replaced. It is also noted that the exhaust fan for this chemical room serves the exit corridor. Further investigation from a Mechanical Engineer with knowledge in venting chemical rooms should be undertaken to ensure the safety of this area for staff. Janitor room requires to be fire separated with 1 hour resistive rating. Provide a fire rated door to the Janitor Room (Refer to Photo A12 and A13).

A12 - Chlorine gas room door requires to be fire rated for life safety.

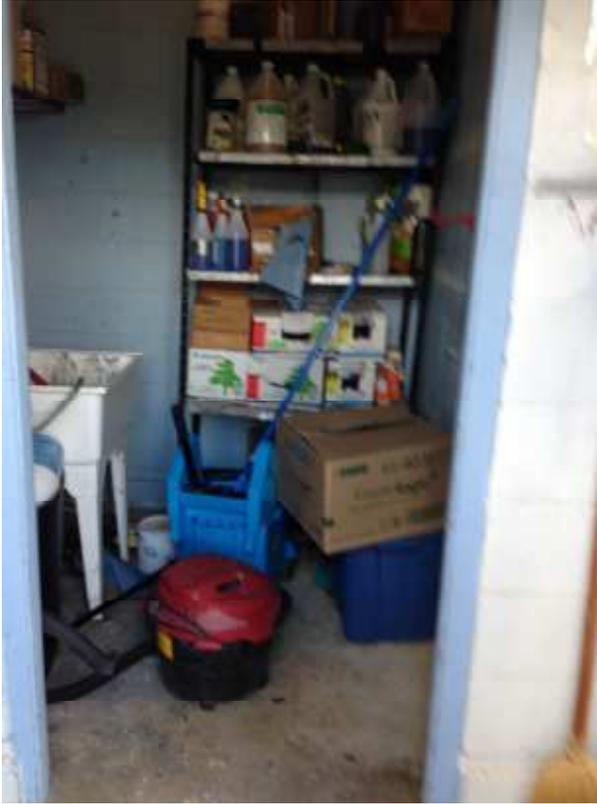
A13 - Janitor room requires a fire rated steel door and frame.

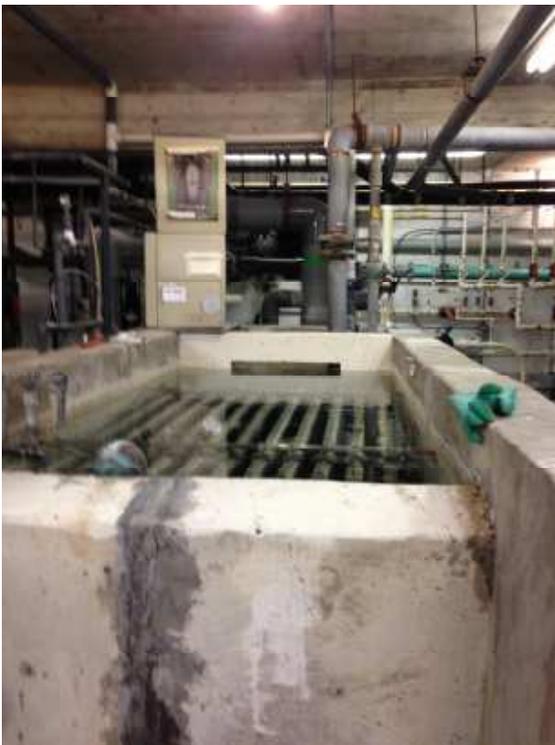
The basement formed concrete for the filter tanks has severe cracking that should be repaired. (Refer to Photos S1 and S2). Swimming tanks are noted as having fault cracks from the wading pool through to the diving tank. The pool liner is pulling away from the pool wall and showing discoloration. In some areas, the concrete appears to be crumbling behind the liner. Further investigation is required to determine if ground water is filtering through cracks in the pool structure and causing deterioration.

S1 - Structural foundation cracks

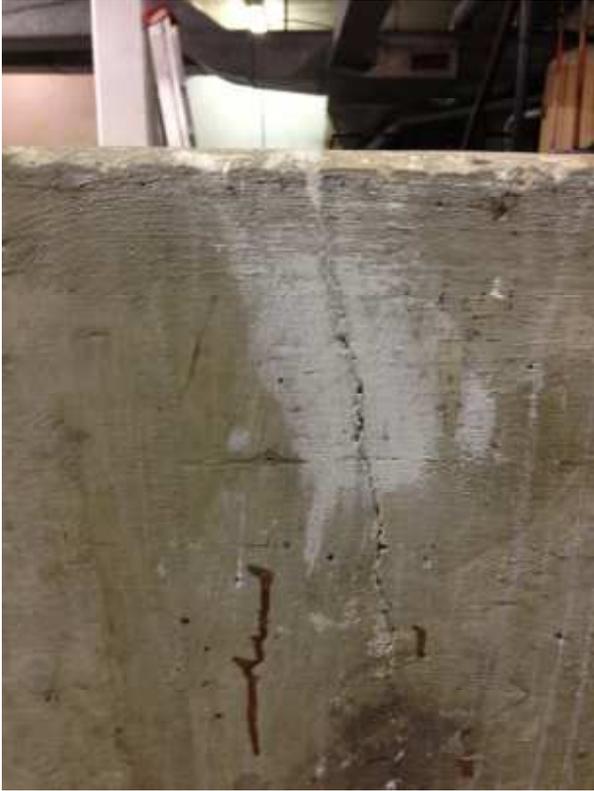
S2 - Structural foundation cracks
